Sidewalk Inventory

Dysart Connectivity Assessment

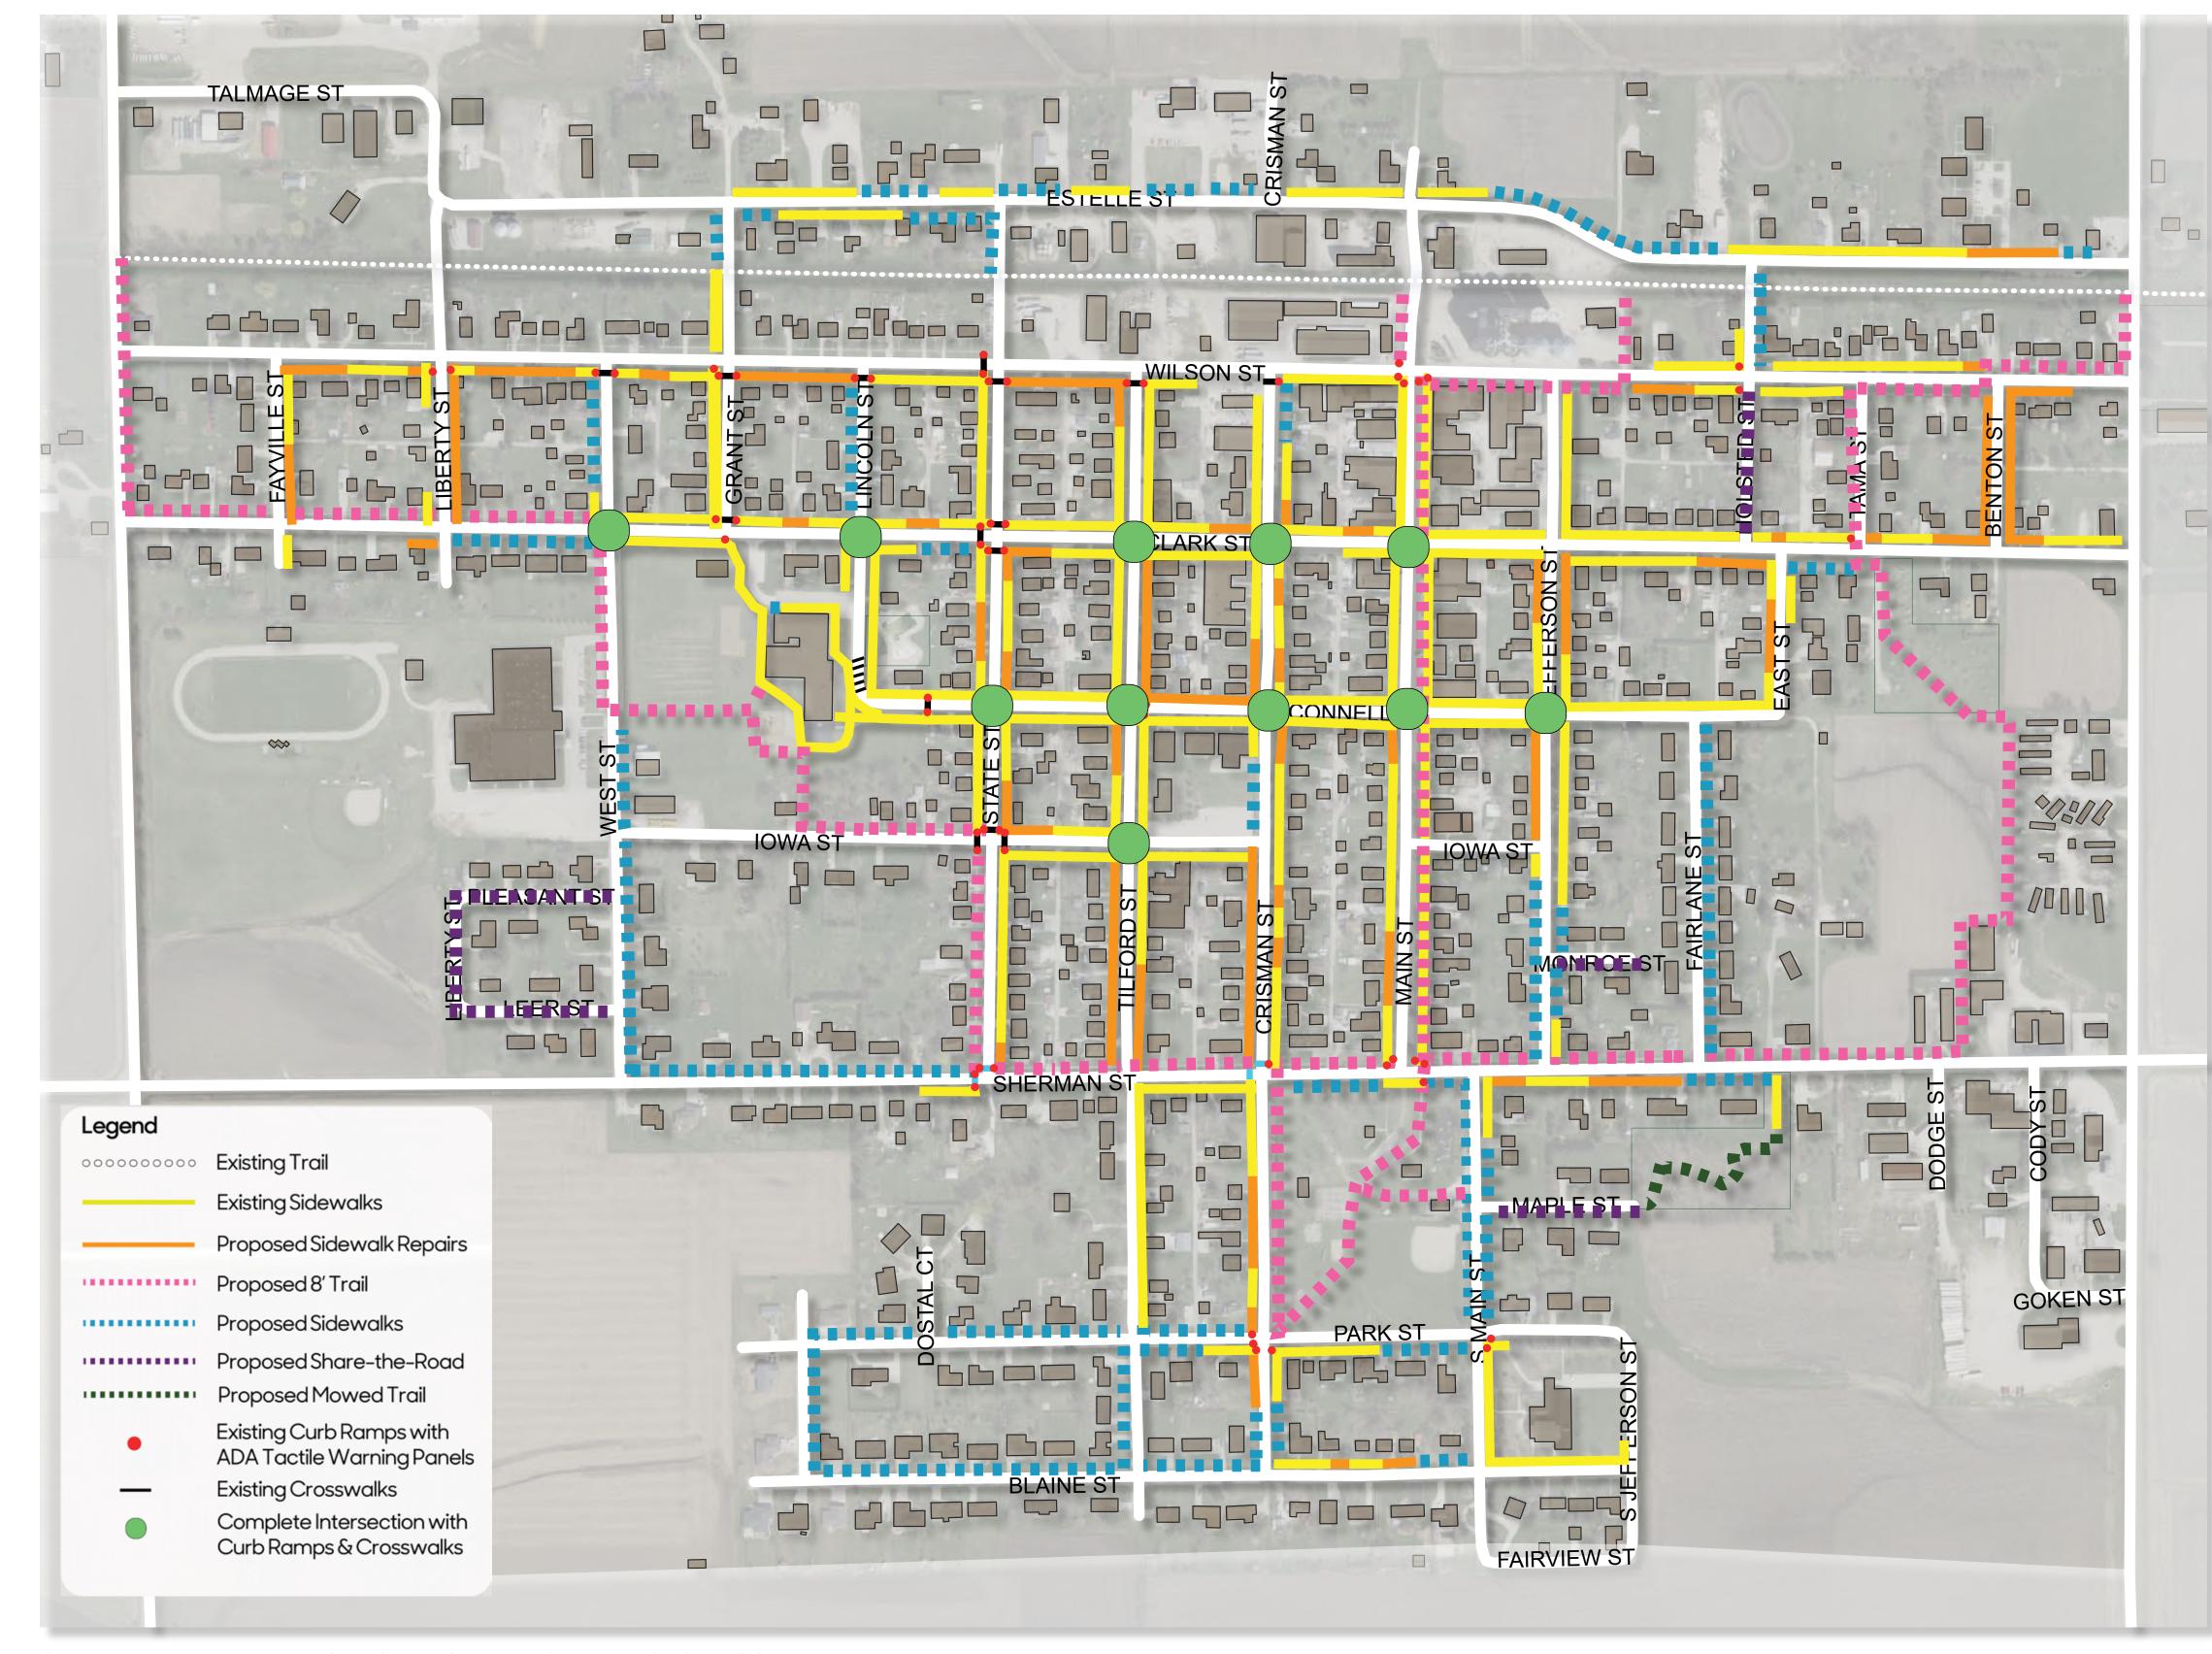
An assessment of existing sidewalk conditions and proposed sidewalk locations.

Using this inventory, the design team was able to propose where new sidewalks could go and where sidewalk repairs were needed.

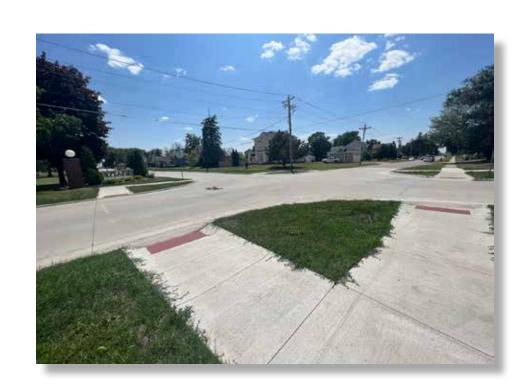
An example of a complete intersection with curb ramps and ADA tactile warning panels. Complete intersections are primarily on Connell and Clark Streets, which serve as primary routes for children to walk to schools.
