## Inventory

The design team performed a sidewalk inventory that details the quality of Wellsburg's sidewalks according to three categories:

### **RITLAND+KUIPER Landscape Architects**

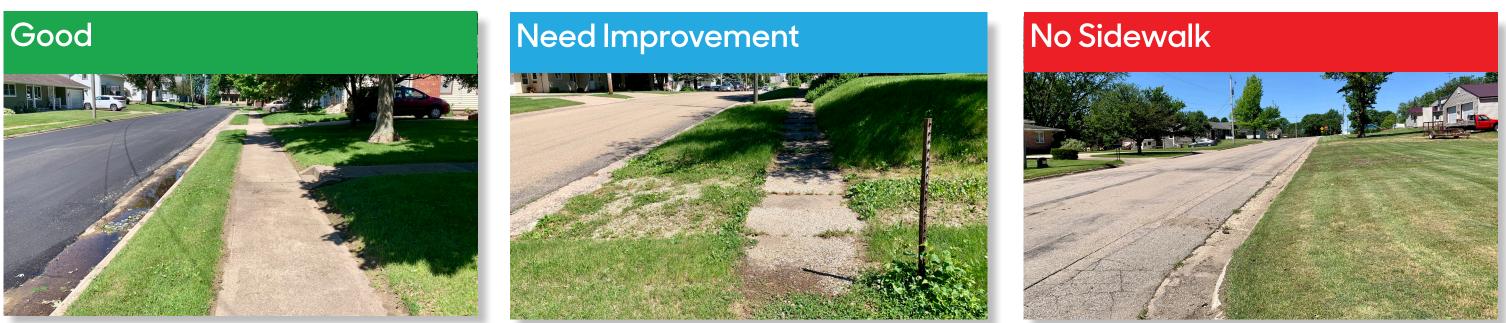
Wilson St. (north side of street looking east)
