Main Street Area

Iowa State University | Trees Forever | Iowa Department of Transportation

SUMMER 2018

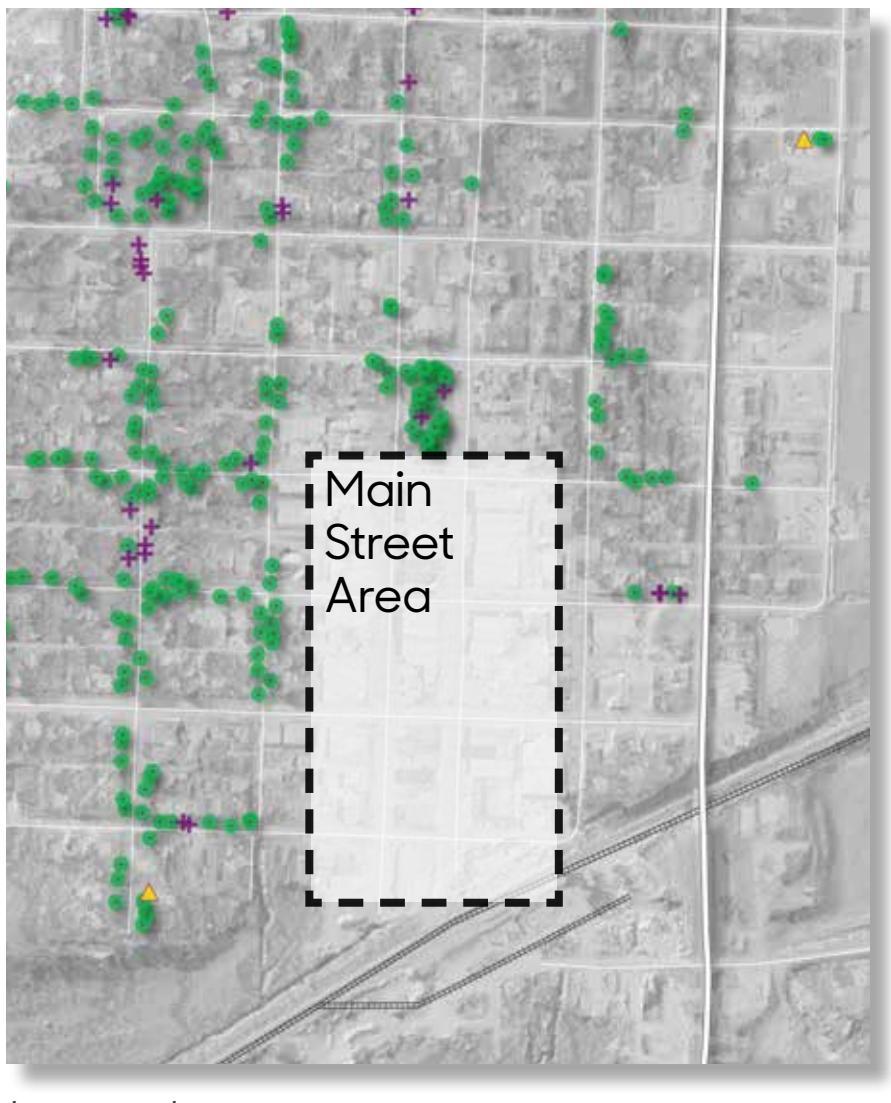
The map above identifies city owned trees surveyed by the lowa DNR. The map identifies healthy, hazardous, and ash trees. Healthy trees throughout the community include oak, hackberry, apple, and maple. The dashed line encompassing the Main Street Area (MSA) highlights the void of trees located in the urban pedestrian areas.

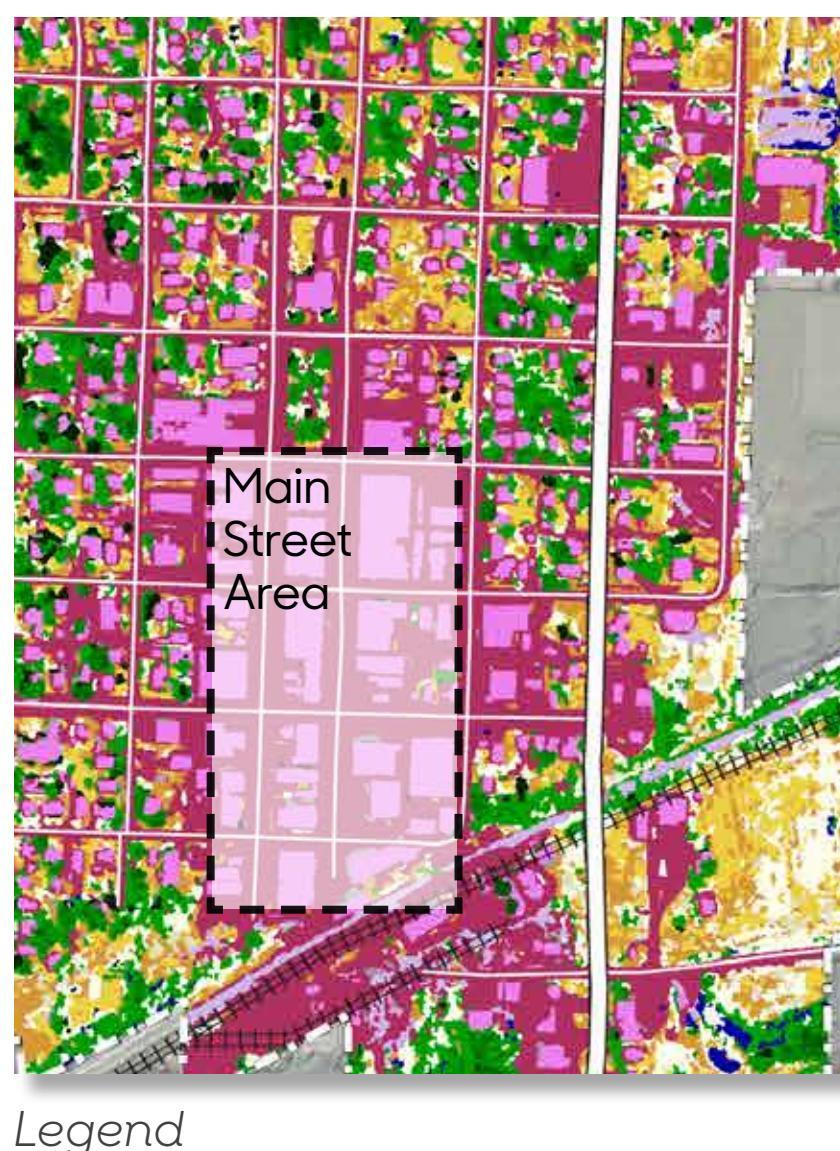
Land Cover Map

The Main Street Area contains the largest congregated area of impervious surfaces. Areas with more vegetation experience reduced solar radiation and lower air temperatures, whereas areas of impervious surfaces experience harsh summer temperatures and increased stormwater runoff.

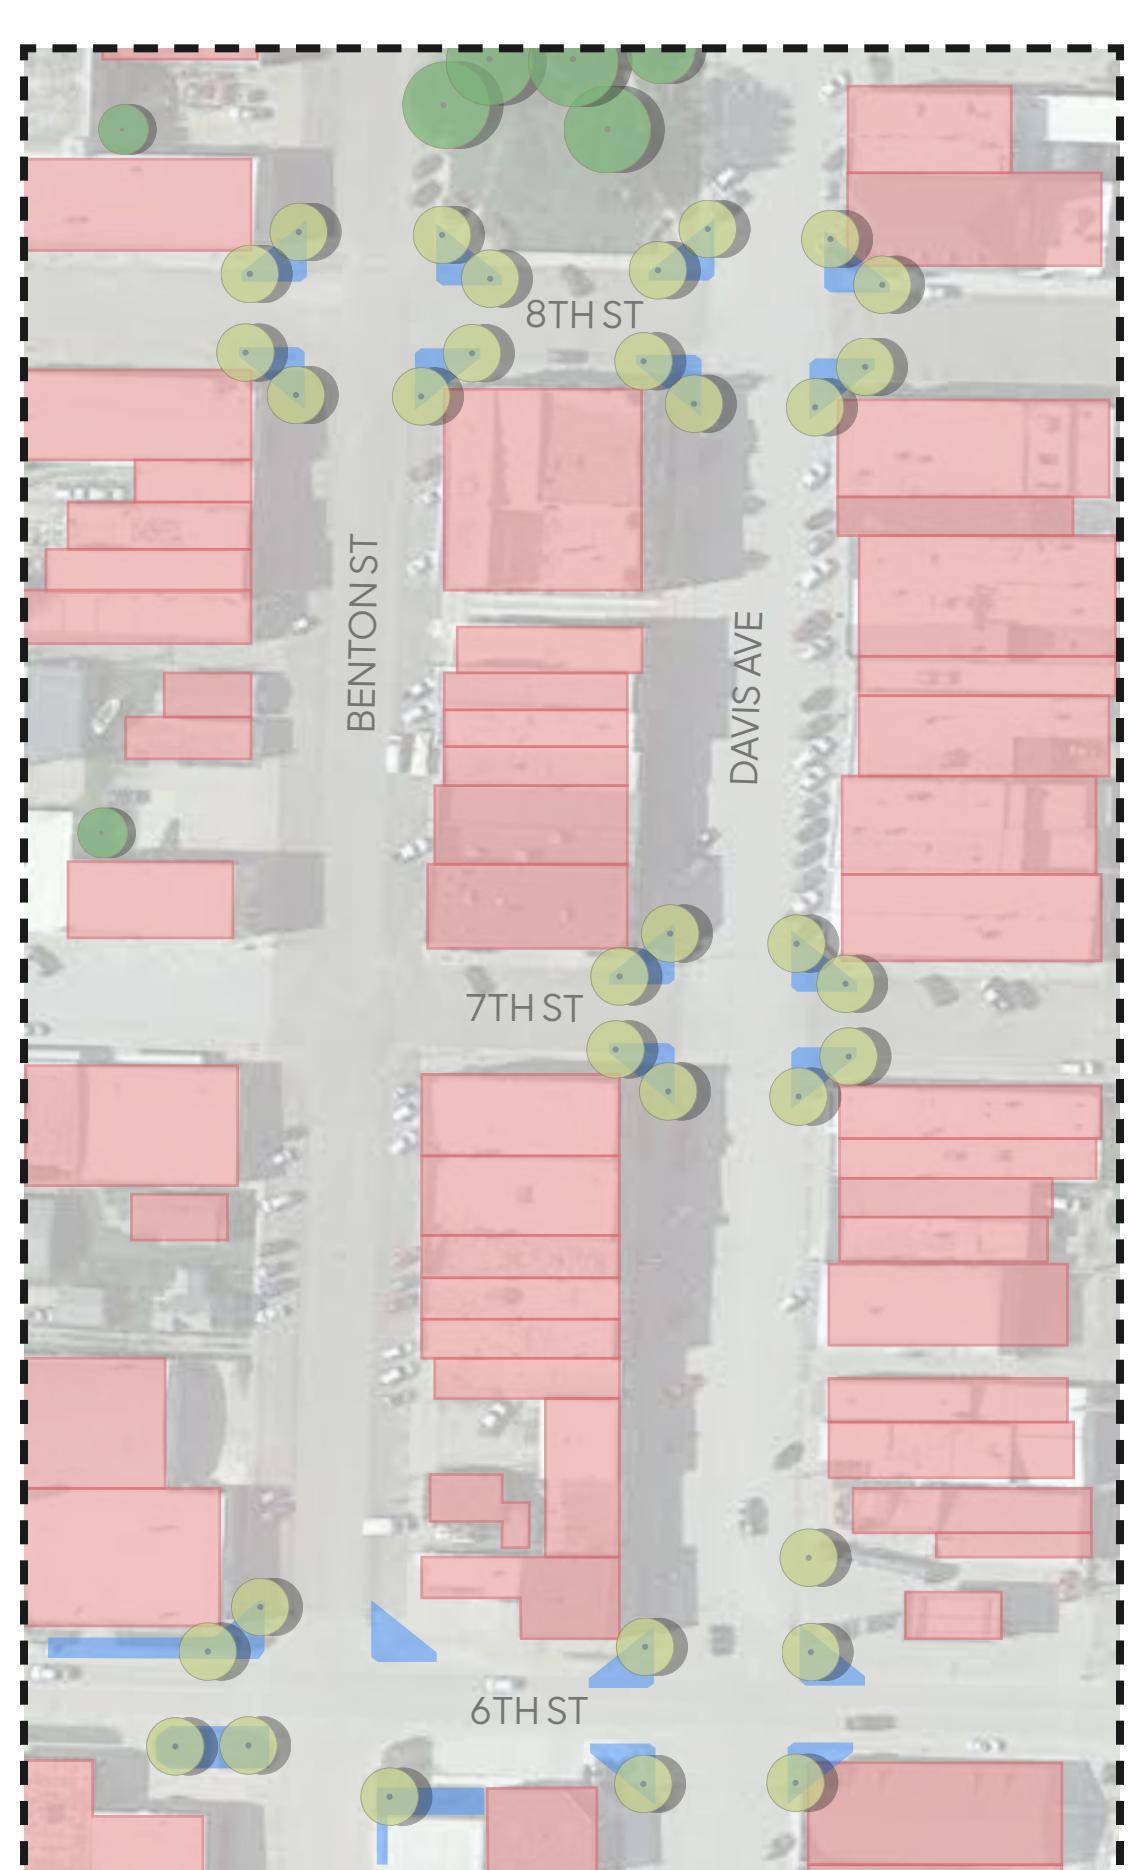
Intersection Improvements \bullet

The plan to the left illustrates the proposed improvements to the Main Street Area, including bump outs and street trees. Bump outs are an extension of the curb which allow sufficient space for tree plantings and other pedestrian amenities. The benefits of trees are numerous and can be quantified. Trees intercept stormwater runoff,

increase property values for adjacent buildings, conserve energy, and sequester carbon. The chart below quantifies the monetary benefit of proposed street trees in the Main Street Area. Having the ability to communicate both the environmental and economic benefits of street trees for the community of Corning can be a powerful means for education.

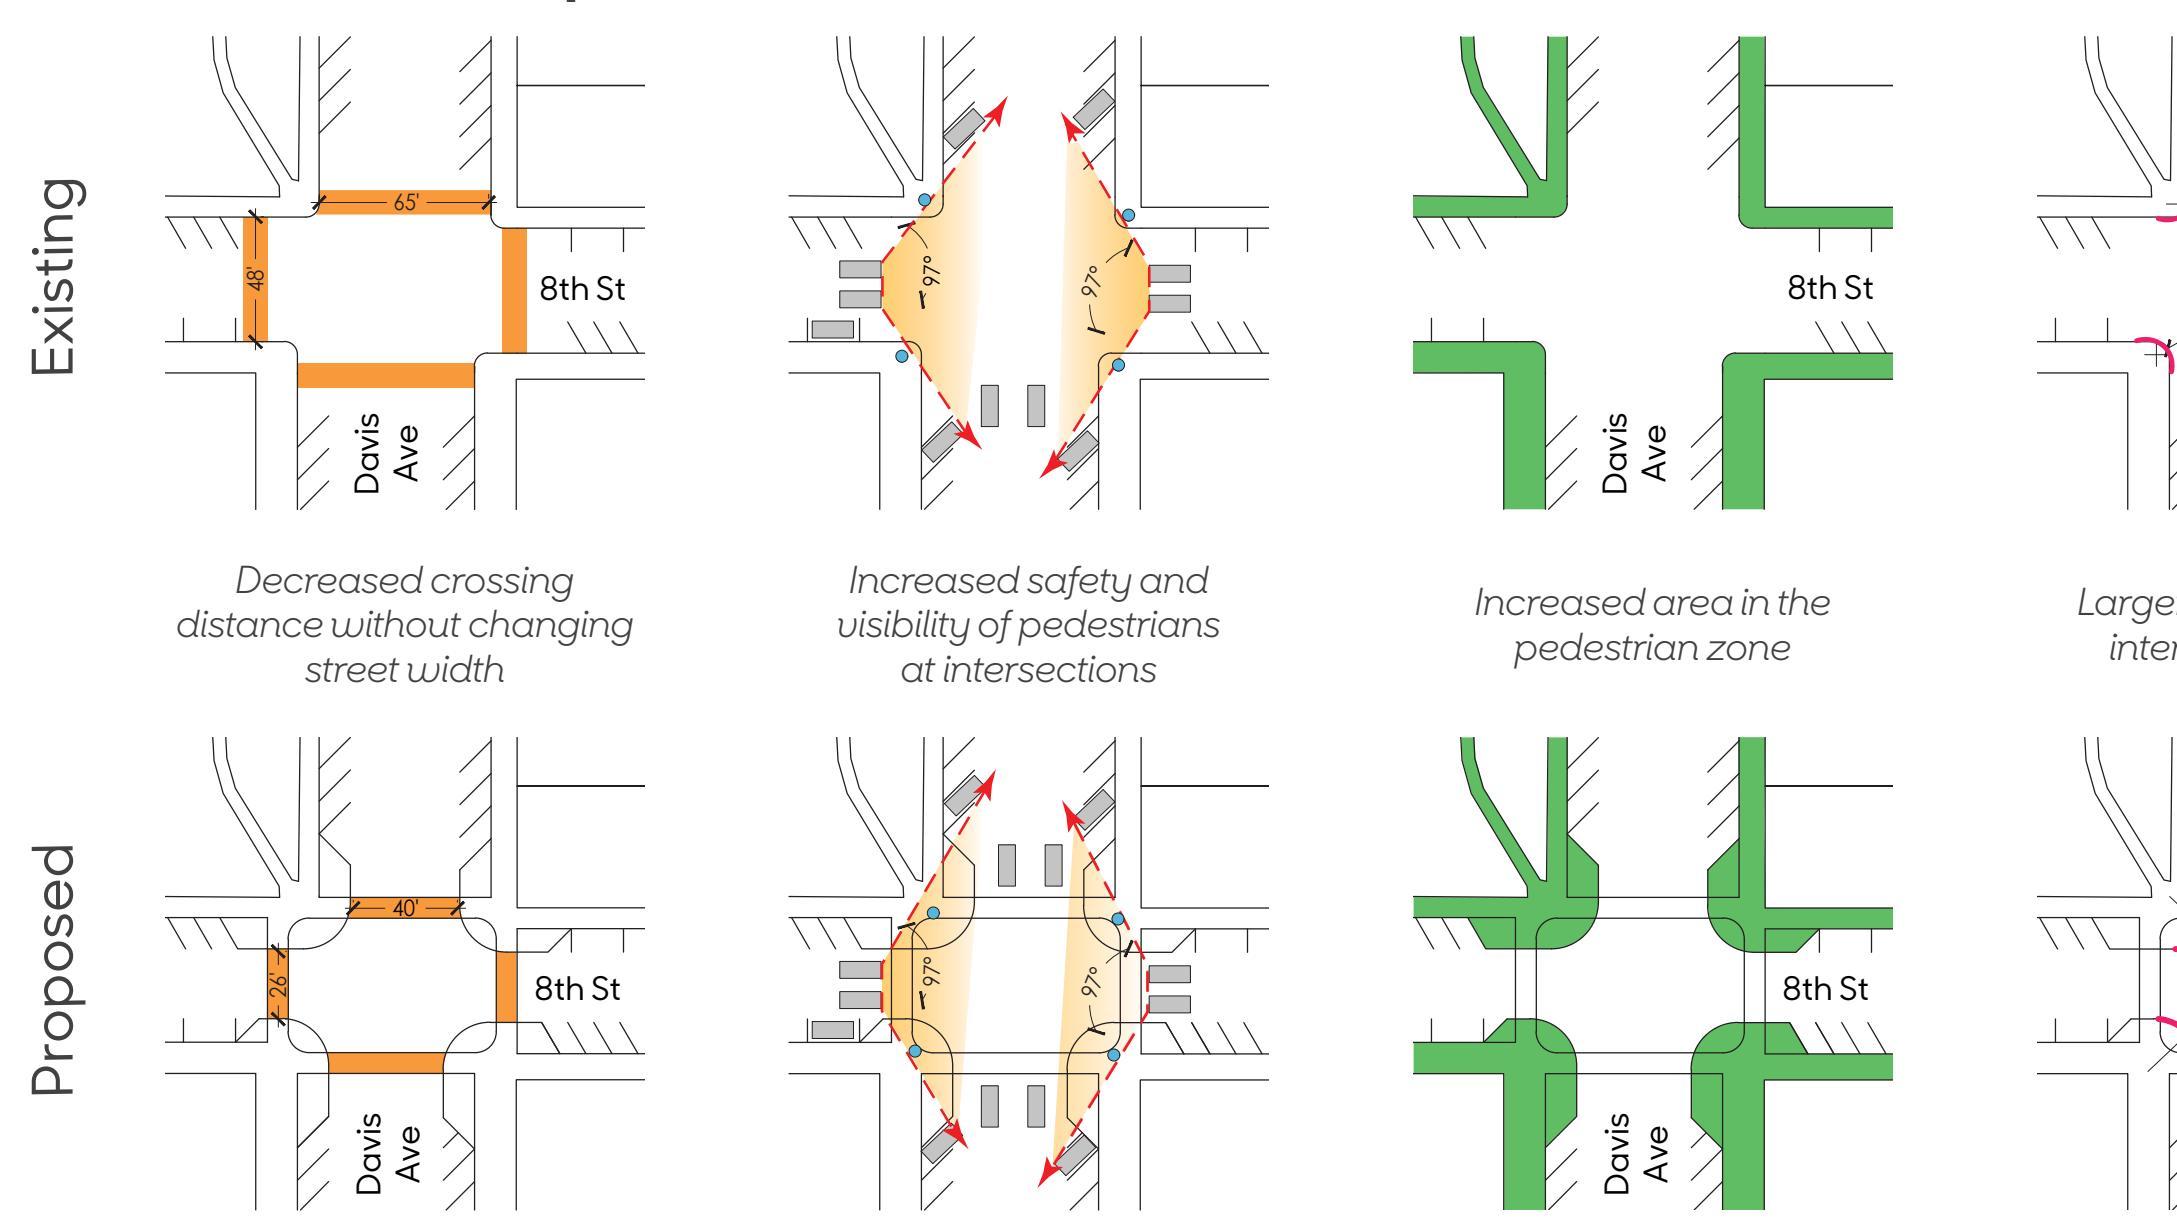
Vignette diagrams highlighting the primary benefits of the proposed bump-outs in downtown Corning.

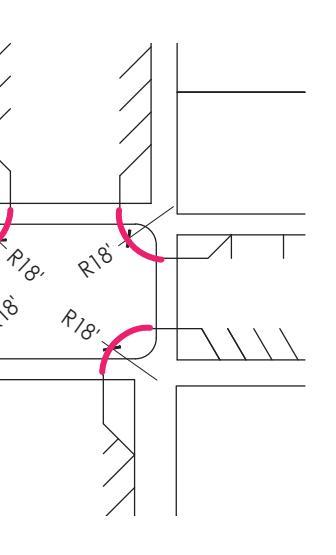
Larger turning radius at intersection corners

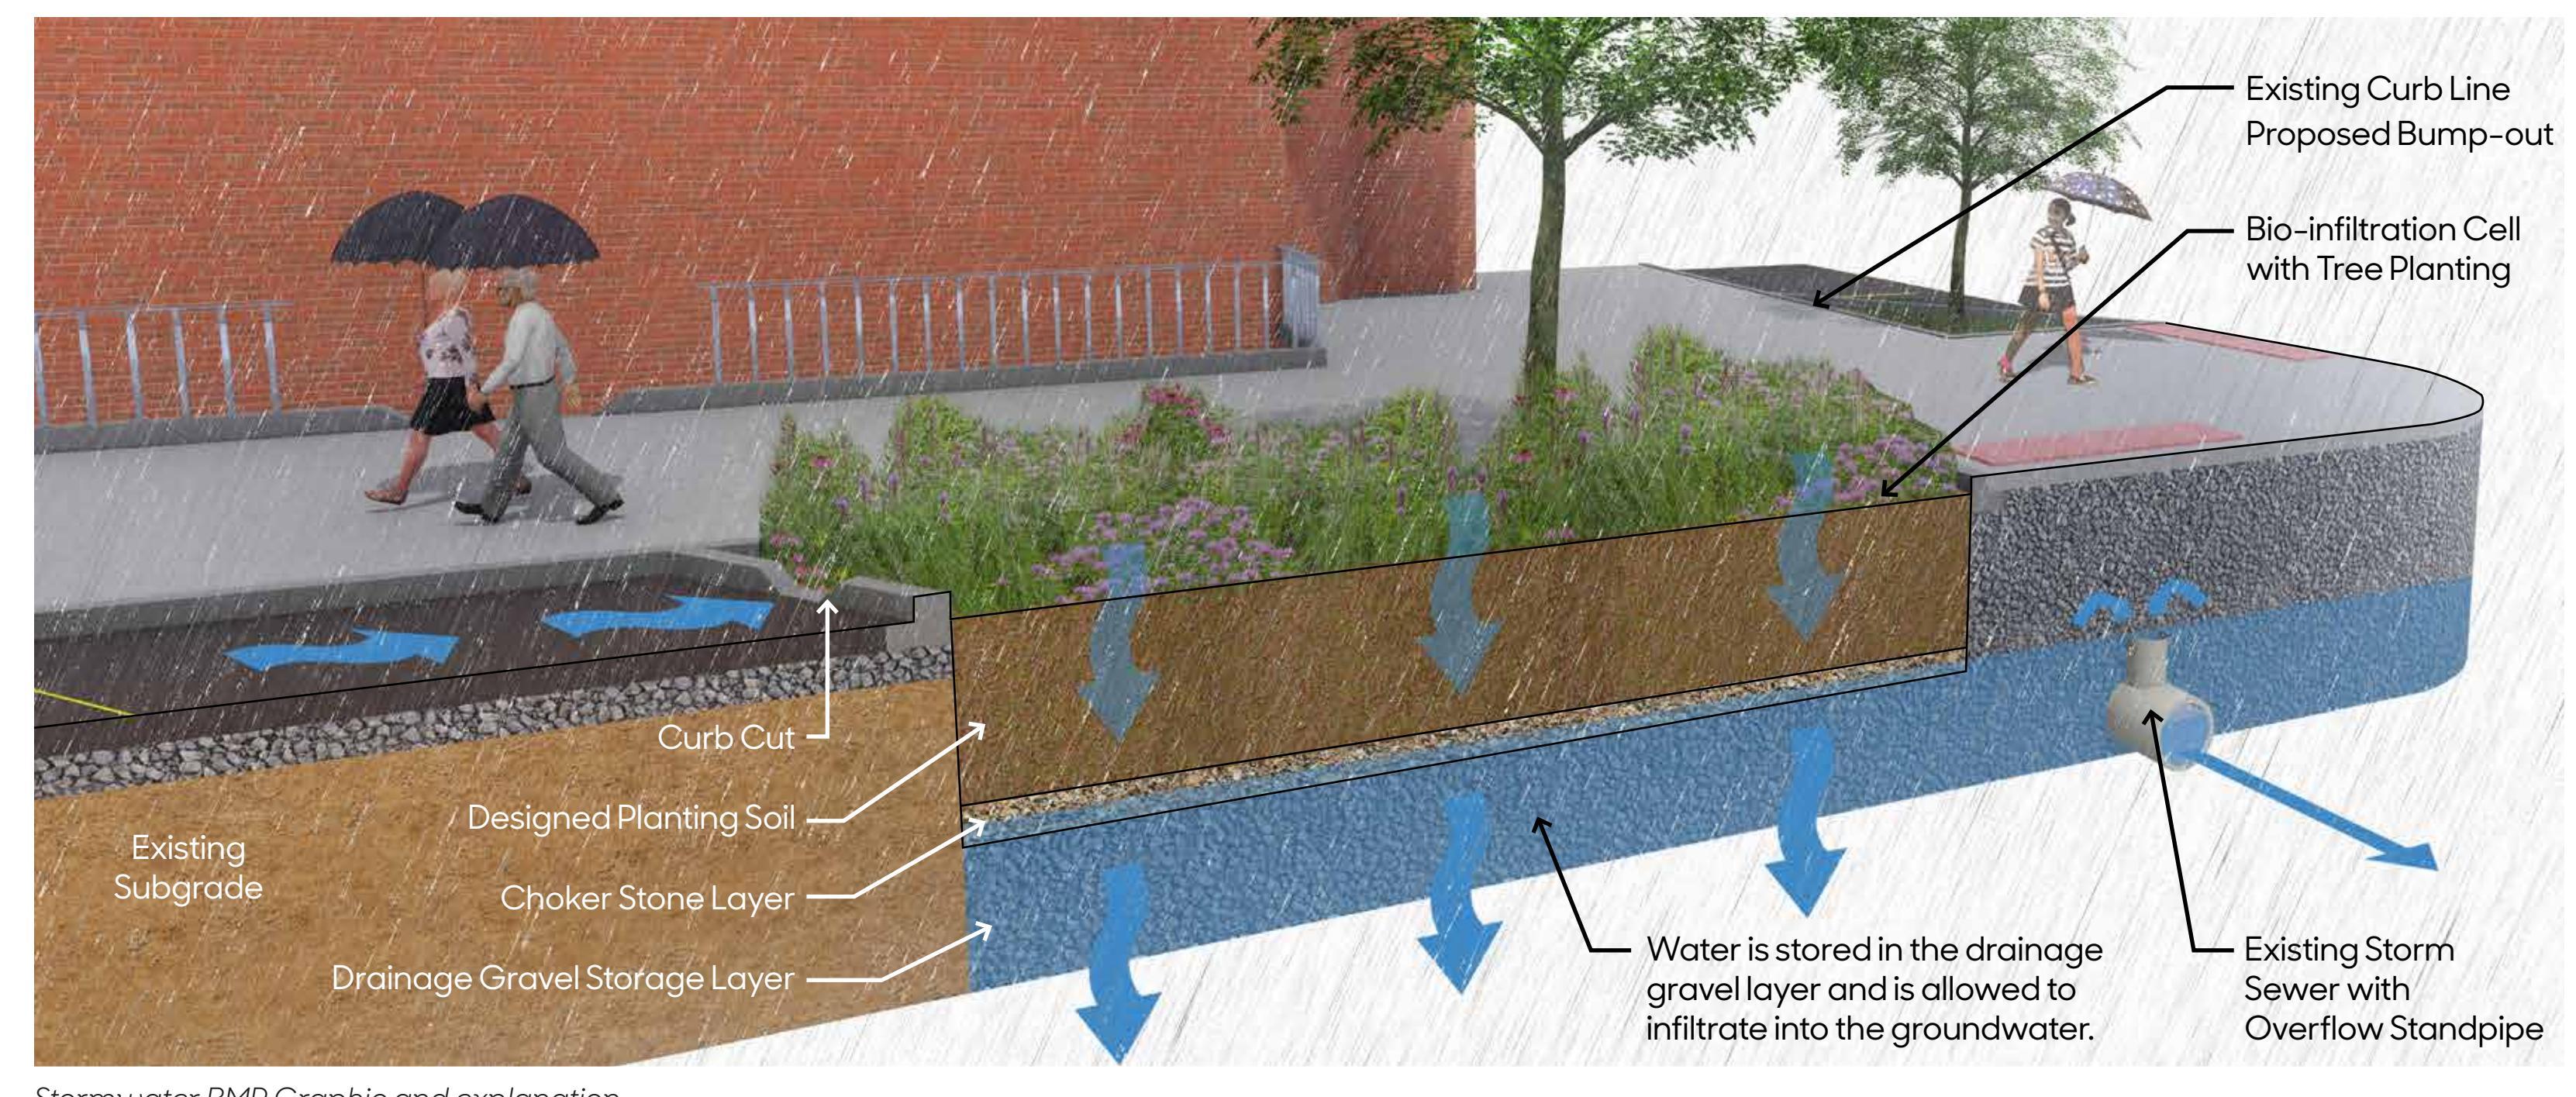
Stormwater BMP Graphic and explanation

The integration of Stormwater Best Management Practices (BMPs) within the proposed bump-outs is a valid means to depressure Corning's existing stormwater system and provide space for trees to grow effectively. BMPs capture and store volumes of intercepted water, as well as, filter and clean water before it reaches the river.

Corning's Main Street Area has a consistently steep southern slope. During rain events, large amounts of water can be seen streaming down Davis and Benton Ave, making the streets impassible at times. The existing stormwater infrastructure is not able to handle the extreme pressures put on it, often decreasing the life expectancy of the system.
