## Transportation Inventory and Analysis

# Colfax

IOWA'S  
LIVING  
ROADWAYS

Summer 2016

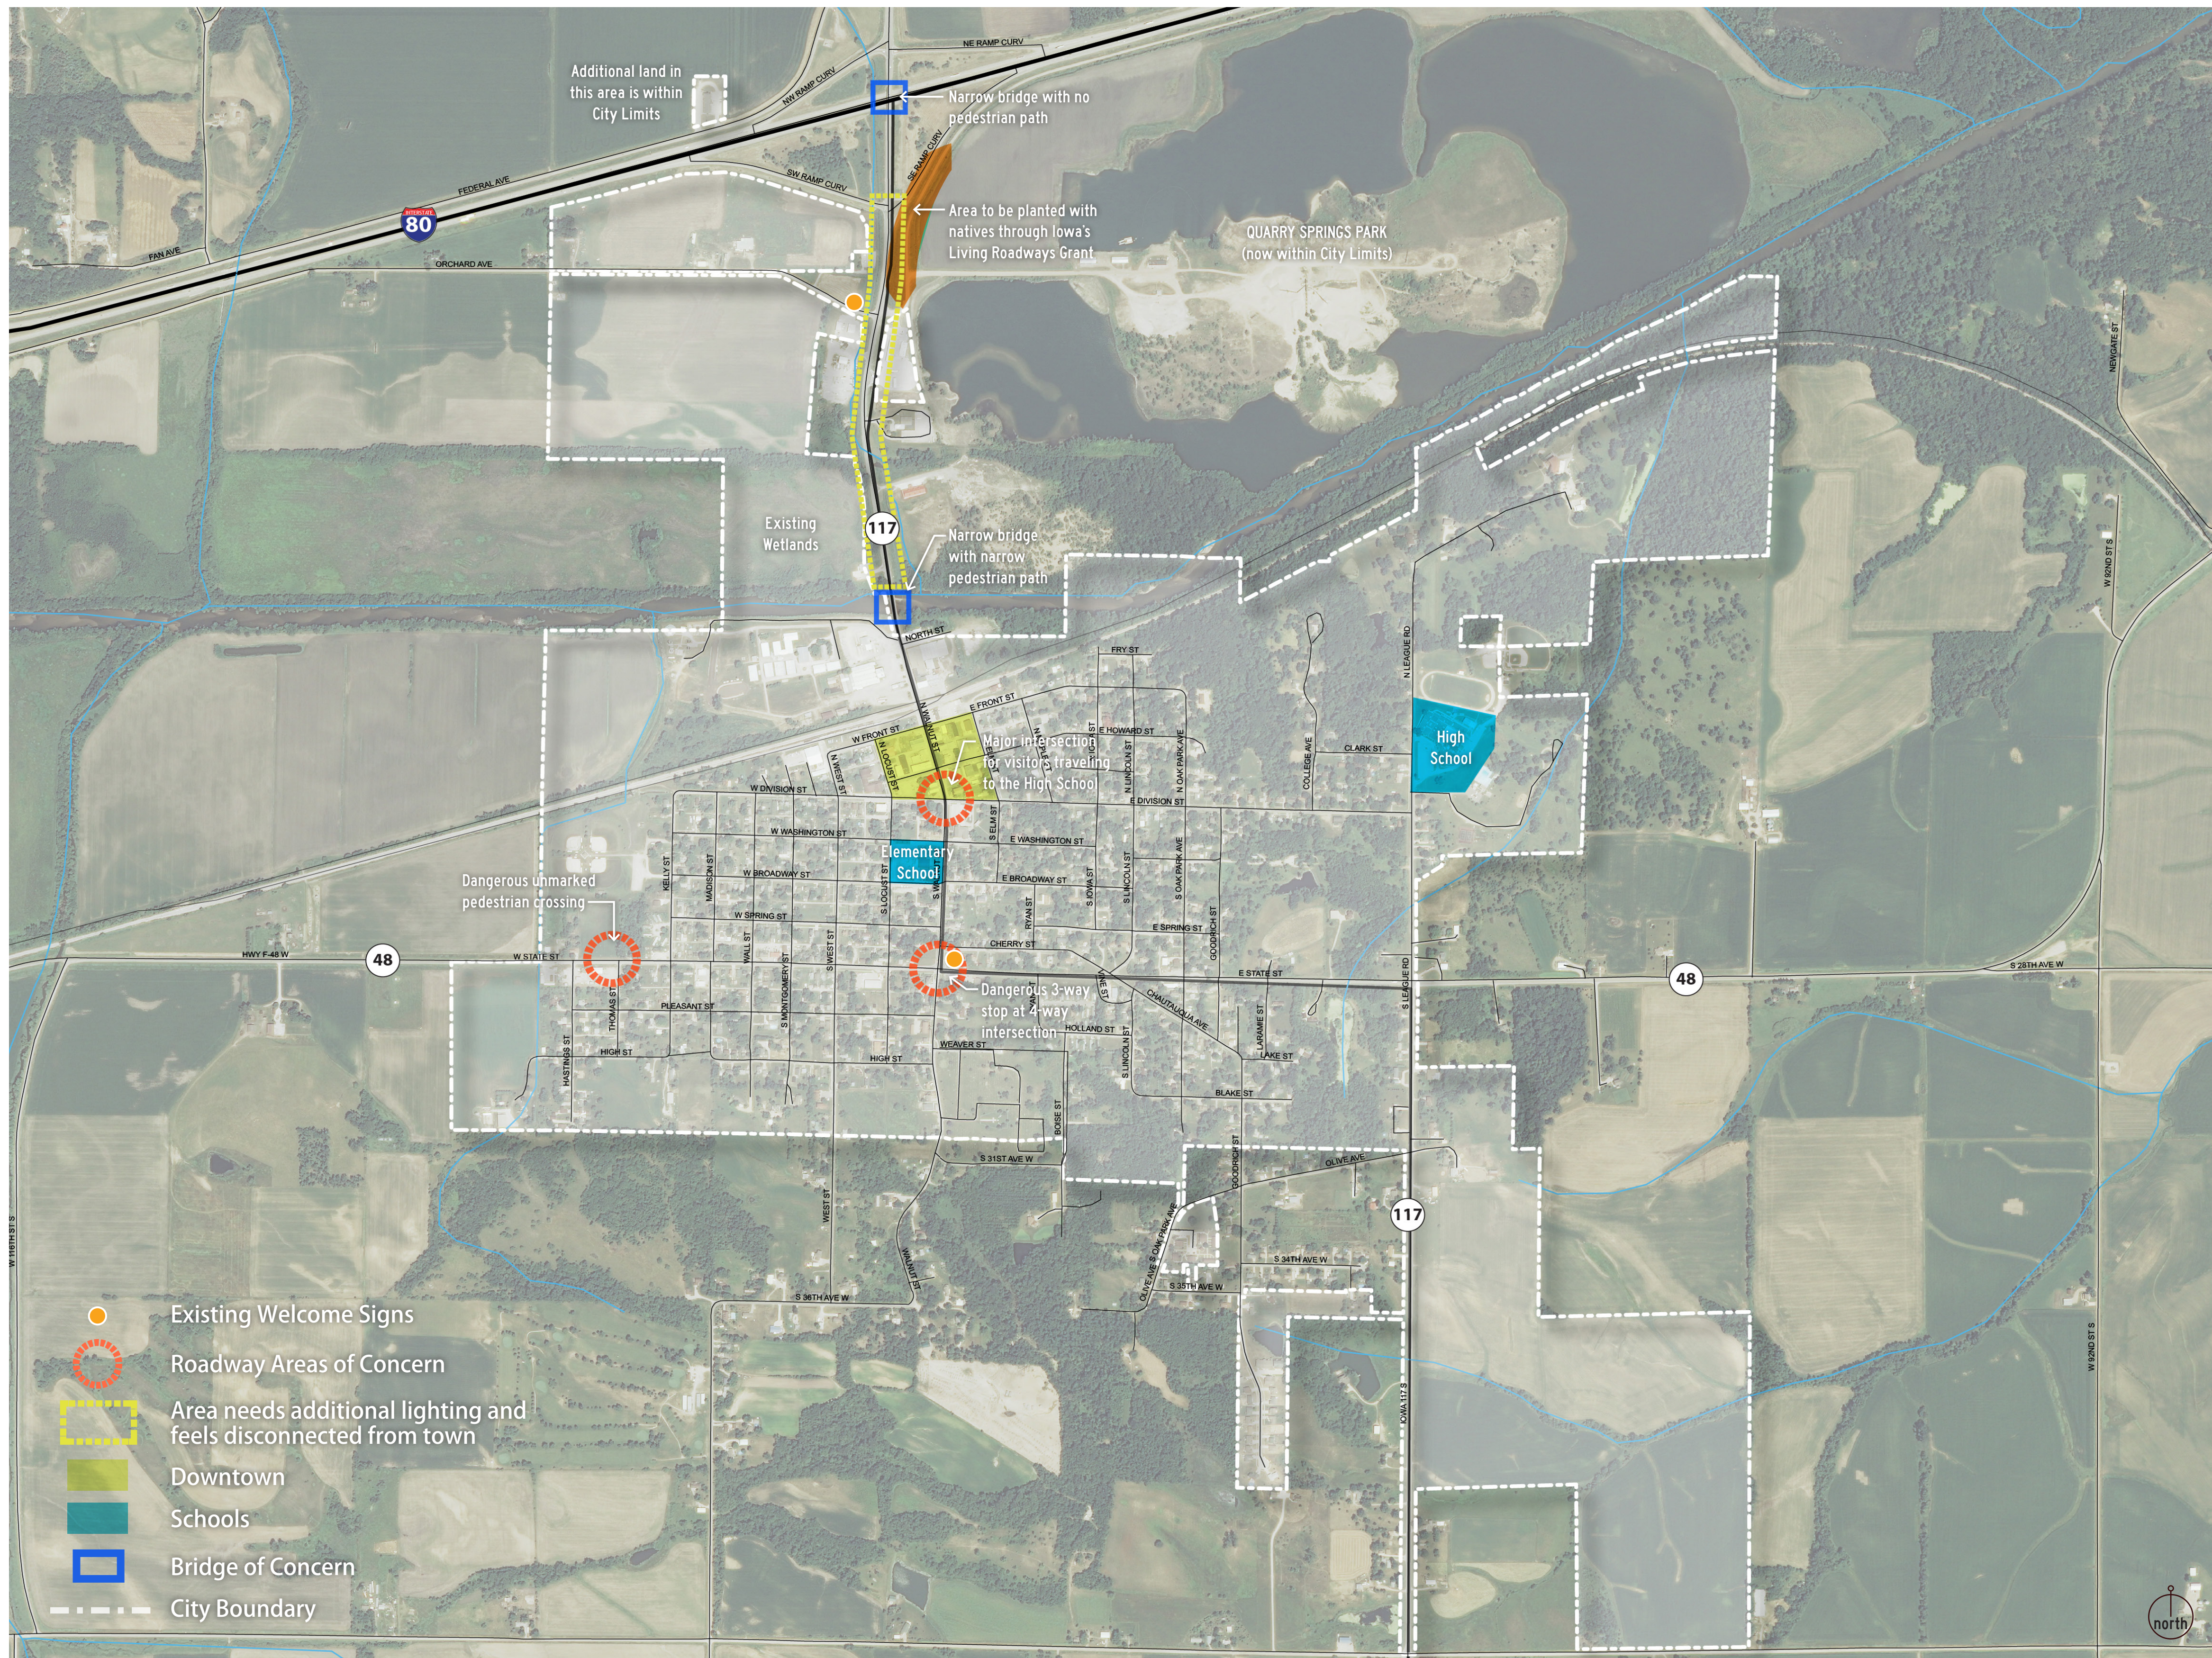
The vast majority of people entering Colfax do so in their personal vehicles from Interstate 80, which cuts through the north edge of town. From Interstate 80, drivers take Highway 117 south nearly a mile before entering Colfax's historic downtown. Highway 117 continues through town and connects to Highway 163 in Prairie City, approximately 6 miles south of Colfax. Although there is an entrance sign near Interstate 80, visitors don't realize the city boundary does in fact lead all the way to the interstate. This portion of roadway between the interstate and downtown is also not very well lit, which is a safety concern. To the east of this area is Colfax's new park; Quarry Springs Park, which is bound to be a great regional draw for the community. With that in mind, the absence of pedestrian paths of travel throughout town, especially the disconnect from this area, is a valid concern of many residents.

There are multiple points of conflict along Highway 117 as it passes through town. Traffic speeds are often excessive in the downtown area and measures are not taken to adequately protect pedestrians. The intersection of Highway 117 and Division Street is heavily used as an access route to Colfax-Mingo High School, but is not properly signed. The worst intersection for vehicular conflict is where Highway 117 meets State Street (F48). This 4-way intersection has a 3-way stop sign configuration, but does not adequately sign the fact that those individuals traveling south on Highway 117 do not have to stop. This creates a dangerous scenario that will lead to accidents if not properly addressed. Further west on F48, there is an unmarked pedestrian crossing shown on the map. People use this route to access soccer fields from a city parking lot, and appropriate signage is needed here as well.

Throughout Colfax, there is a significant amount of topographical change. This has made creating and maintaining sidewalks hard for residents, which has created disconnects for those trying to traverse the city on foot or bicycle. This, paired with the poor quality of roads throughout town, make some areas of town practically inaccessible.
