Wellsburg

City Park Improvements

RITLAND+KUIPER Landscape Architects

Iowa State University | Trees Forever | Iowa Department of Transportation

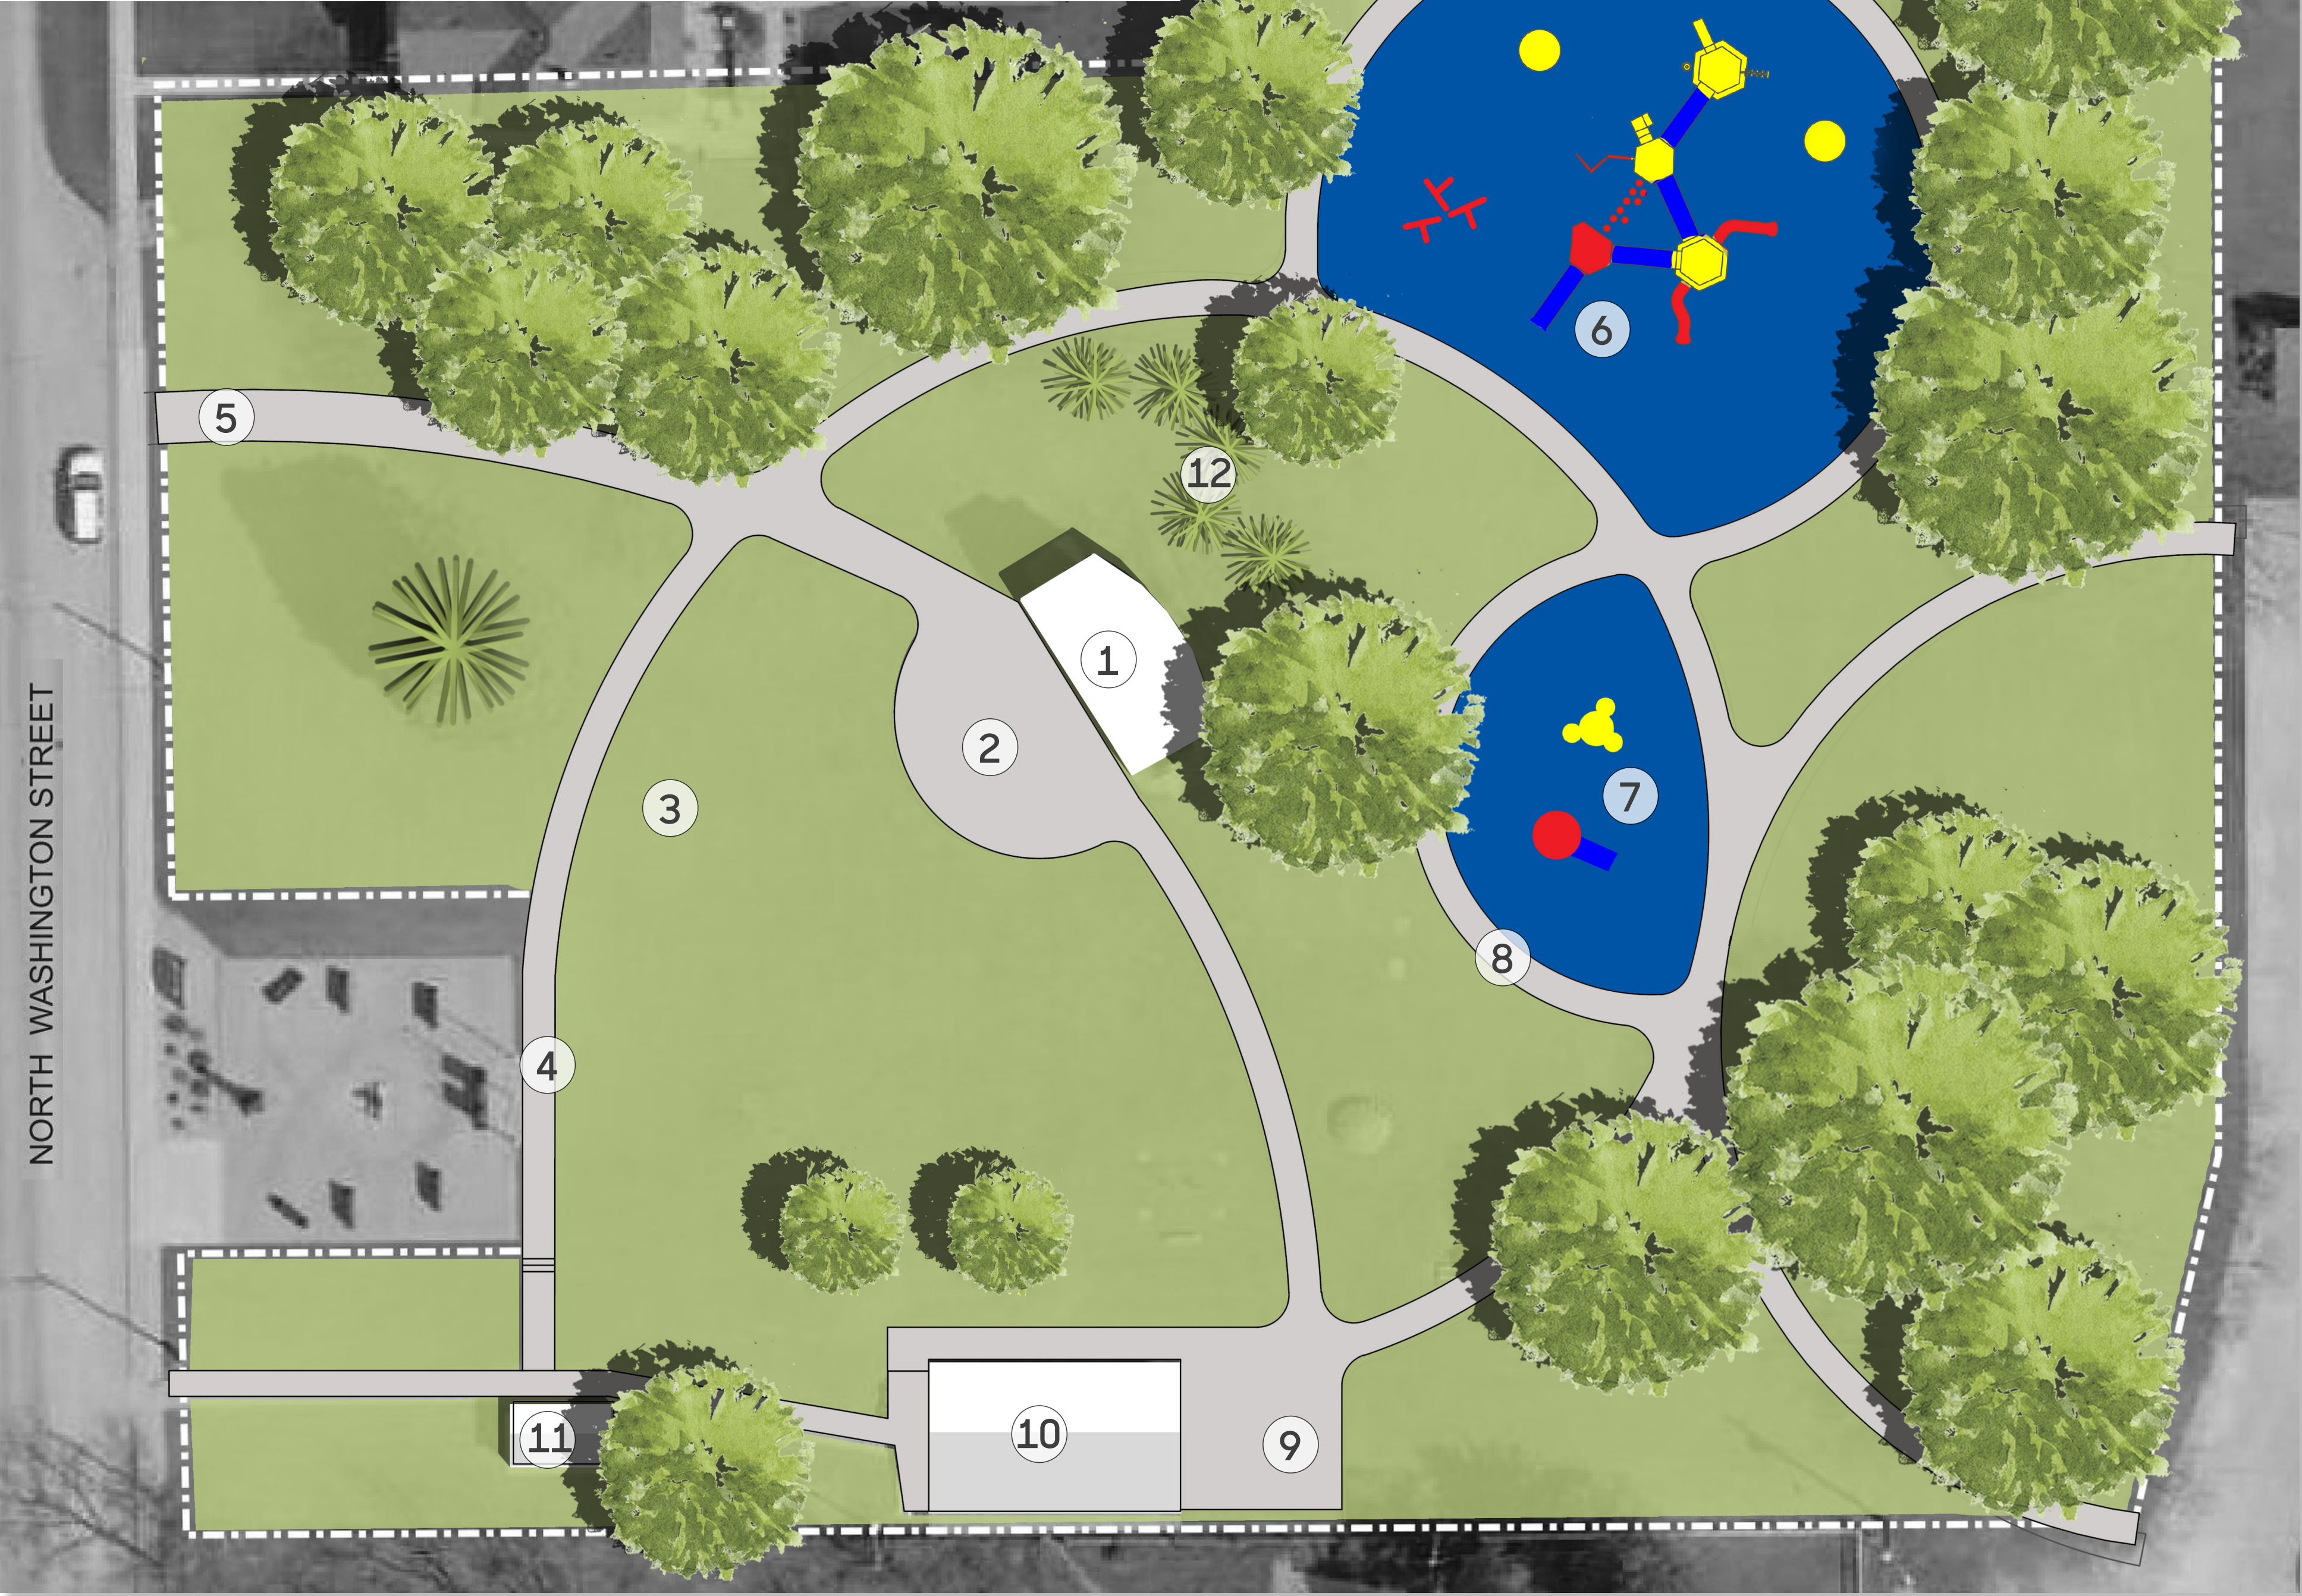
1. Proposed band shell renovation

2. Proposed accessible seating for the band shell

3. Proposed seating on the lawn

4. Proposed sidewalk with stairs to restroom

5. Proposed 8' sidewalk to band shell

6. Proposed ages 5-9 playground equipment
7. Proposed ages 2-5 playground equipment

8. Proposed perimeter sidewalk with benches

9. Proposed outdoor picnic & grill area

10. Existing shelter

11. Existing restroom

12. Proposed evergreen screen plantings

Proposed City Park concept plan shows improvements to circulation and amenities

Wellsburg City Park is set back from County Road T19, which runs north-south, bisecting the park from the community. Access to and through the park is an issue for residents. Most of the residences are on the west and south sides of County Roads T19 and D25 and there are limited designated pedestrian crossings on either of these busy roads, making crossing difficult. Access through the park is impossible for anyone with mobility issues because most of the park amenities are stand alone with no connecting sidewalks. Residents would like to see a paved surface through the park and new play equipment (reference: Emerging Themes, 3c). The Wellsburg City Park concept shows an ADA-accessible sidewalk system that would connect all the amenities in the park. Upgraded

playground equipment designated for ages 2-5 and ages 5-9 replaces the existing outdated playground. The visioning committee plans to renovate the existing band shell with fundraising already underway for the project. Accessible seating is proposed, in addition to utilizing the existing grades for amphitheater-style seating on the lawn. Additional evergreen plantings behind the band shell provide a screen from the proposed playground and add to the ambience of the band shell. The committee is already working with Miracle Recreation for playground equipment and safety surfacing. The addition of paved surfacing to the equipment ensures everyone in the community has access to a fun and inviting playground.

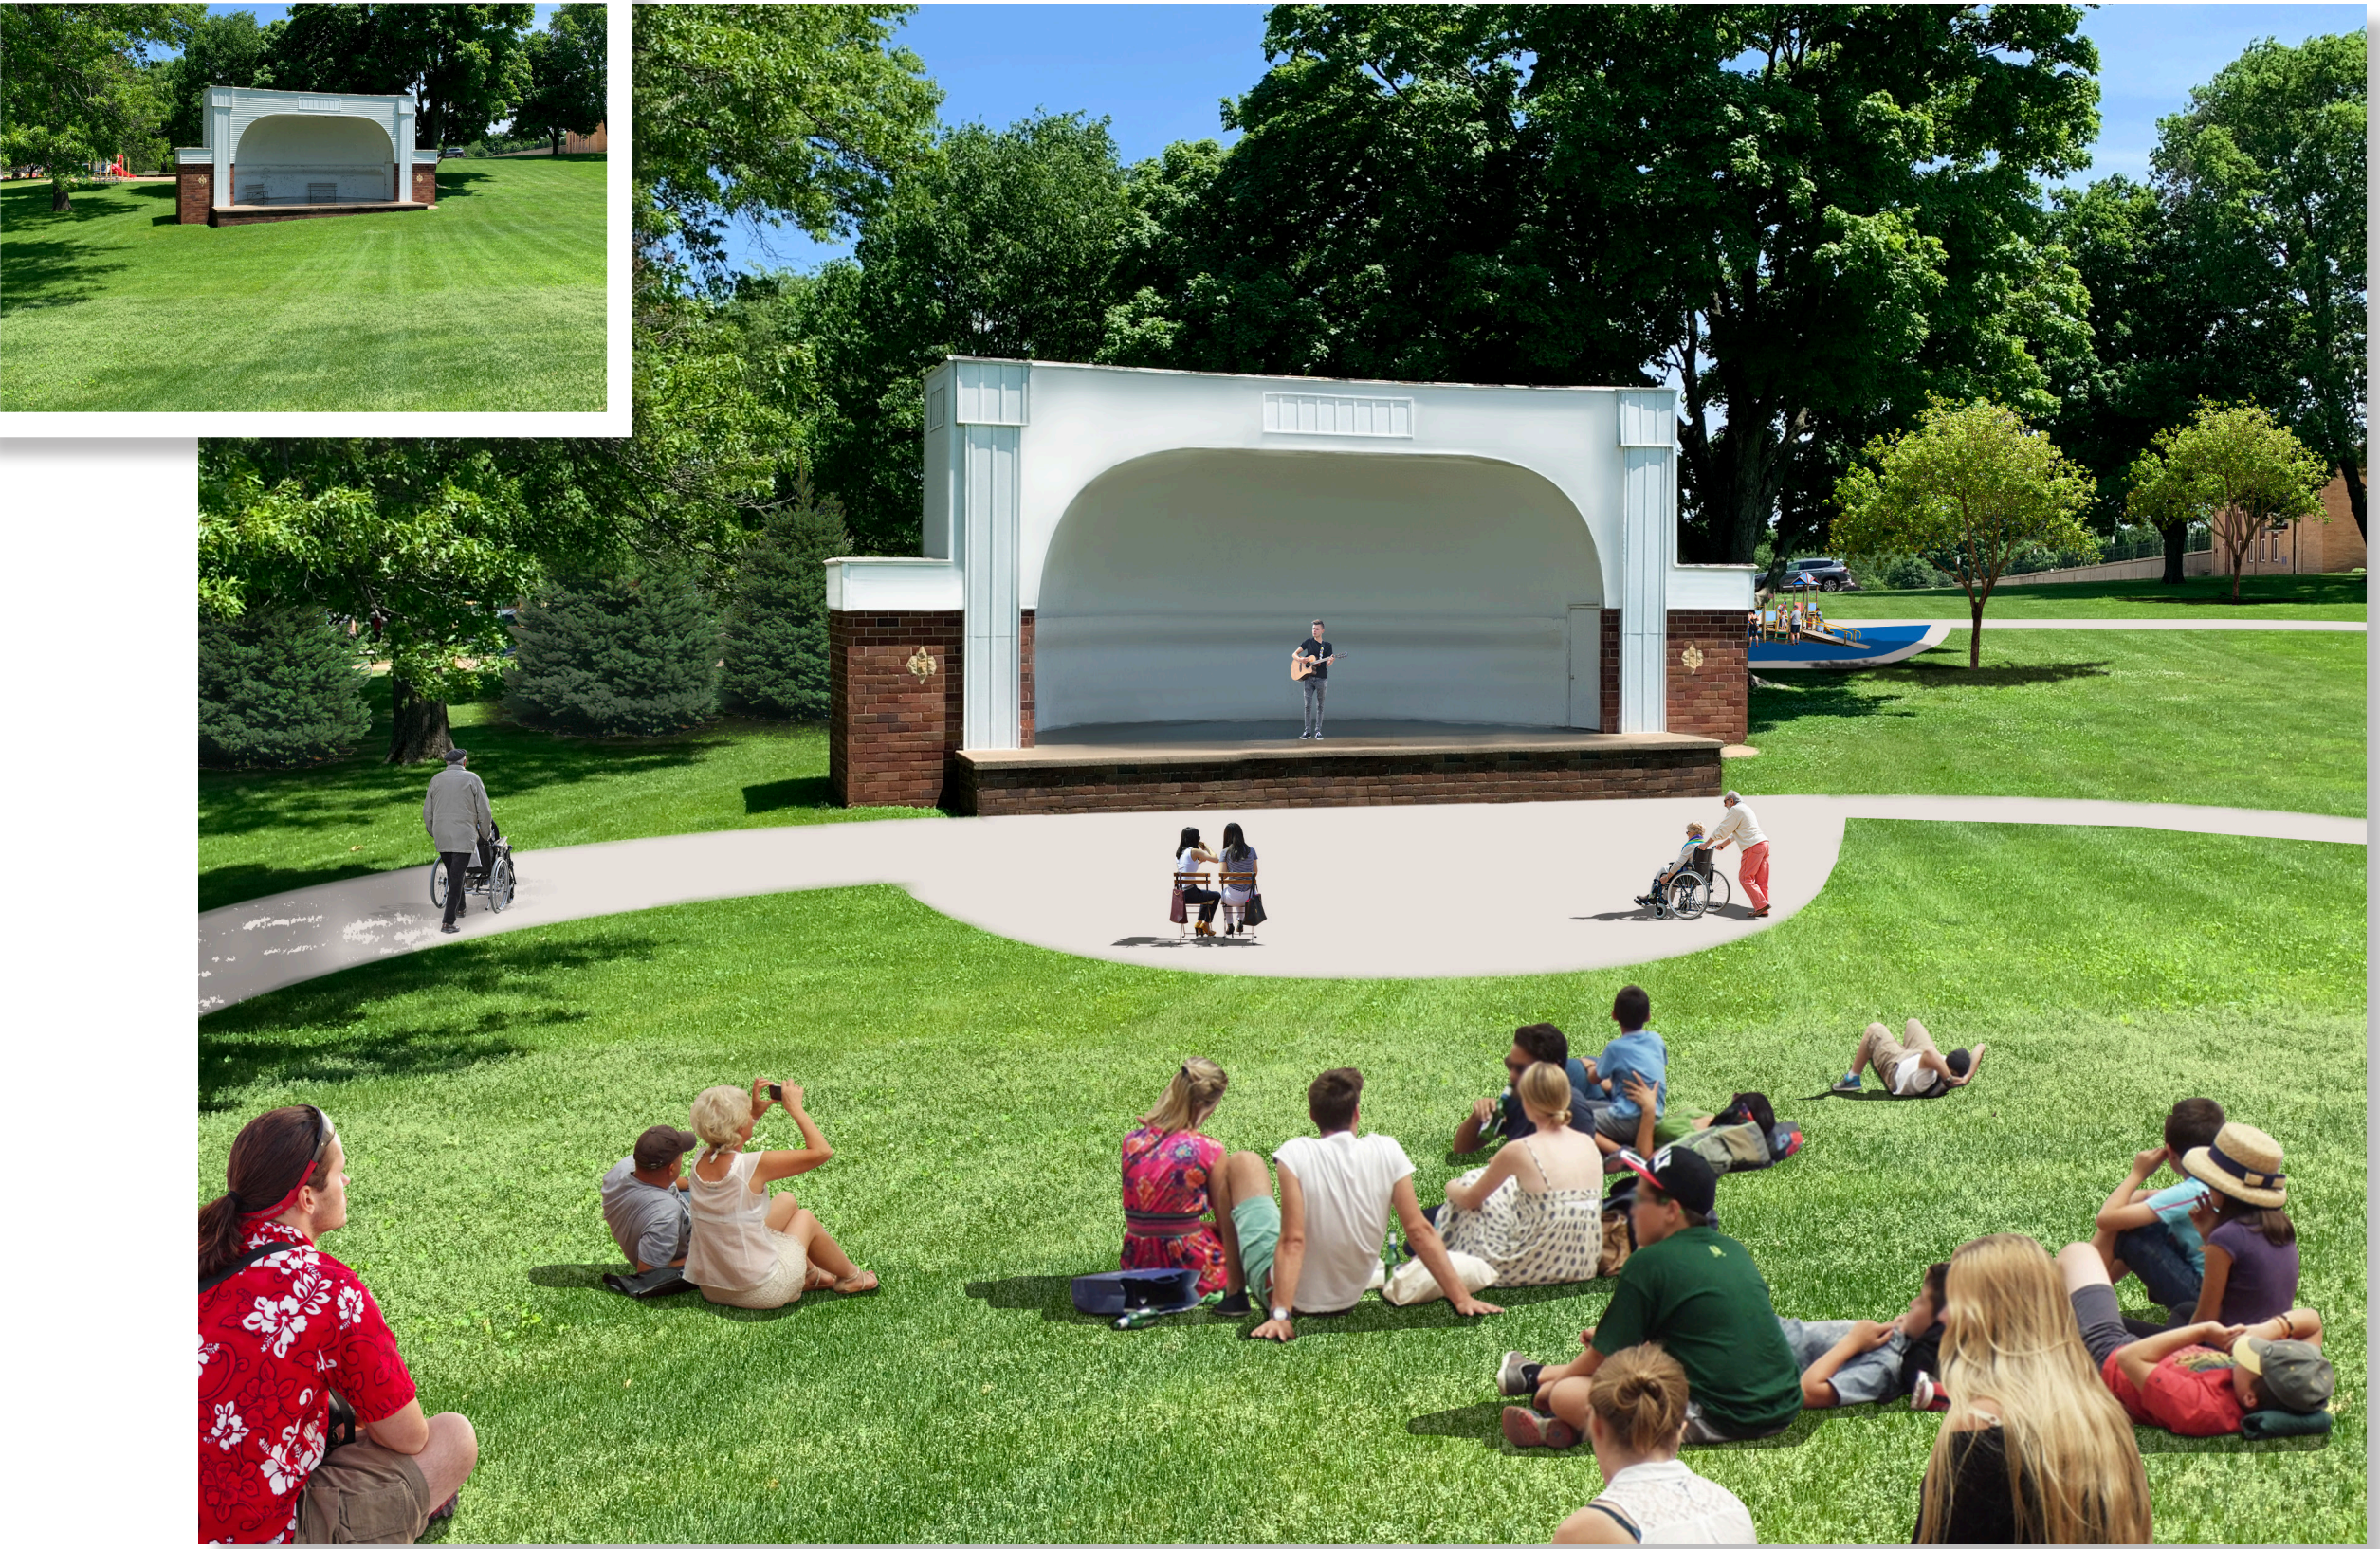
Top left: Existing band shell in Wellsburg City Park
Bottom: Proposed band shell renovation with accessible seating & evergreen screen plantings
